Smithsonian No: 10CN530  
IHSI No: 27-14539  
Created Aug 10, 1988; Updated by Jeffery Holley Sep 4, 2026

| Resource Names * | Parma High School Gym |

| Project | Name | Version | Type | Lead Agency | Overall Eligibility | SHPO Concurrence Date |
|---|---|---|---|---|---|---|
| <u>2026-517</u> | Canyon County Historical Agricultural Resources Survey Phase 3 | 2 | CLG Survey | | Unevaluated | |

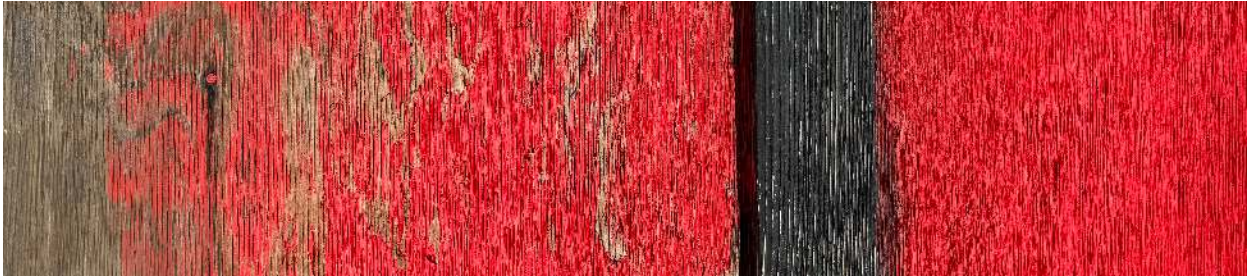
10CN530\_19\_Red\_Painted\_Wood\_1065\_E.jpg

Detail documenting a weathered red-painted wood surface associated with an ancillary building on the south side of the building.

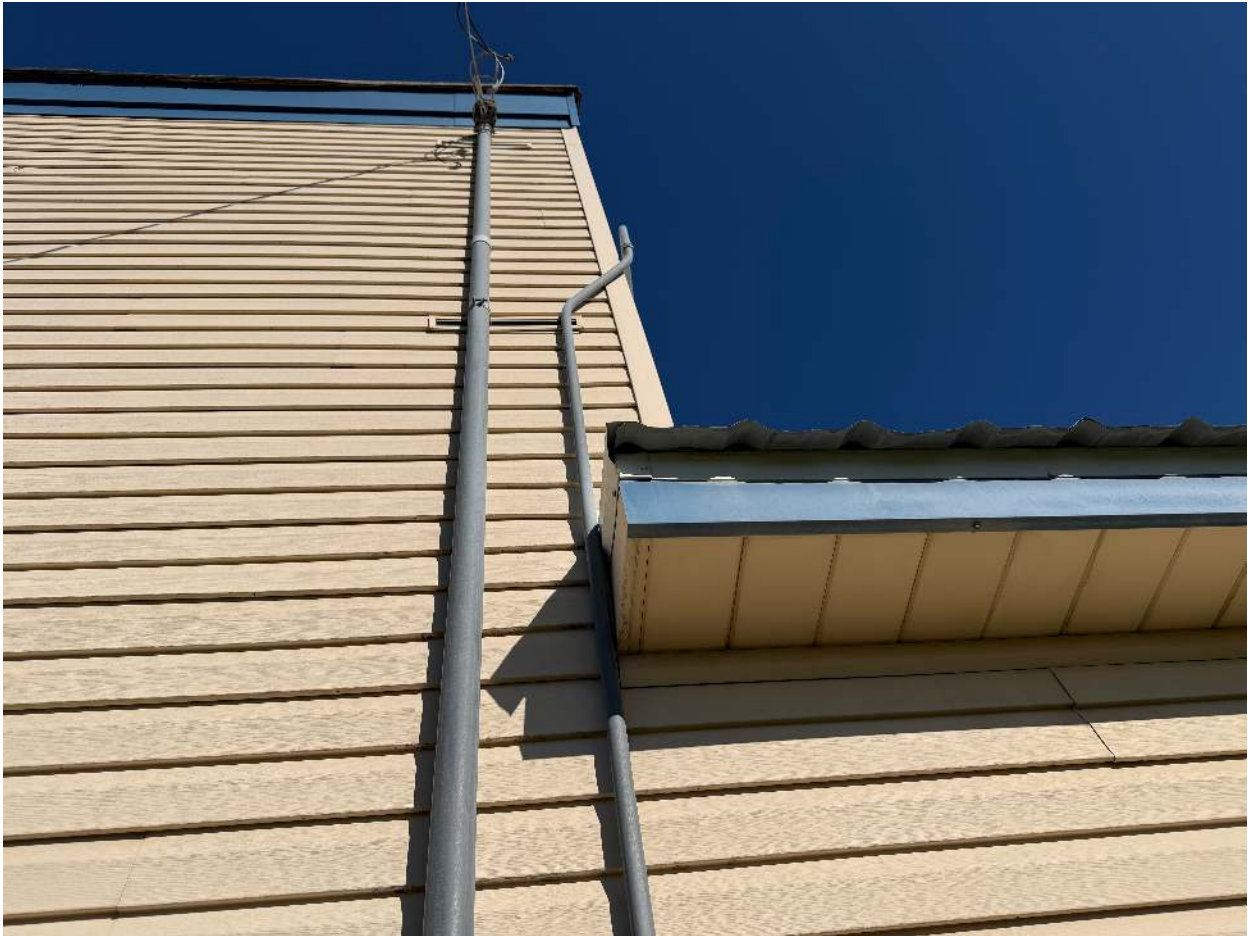
10CN530\_18\_Roof\_Junction\_1064\_E.jpg

Detail showing the junction of the main arched volume and lower attached section.

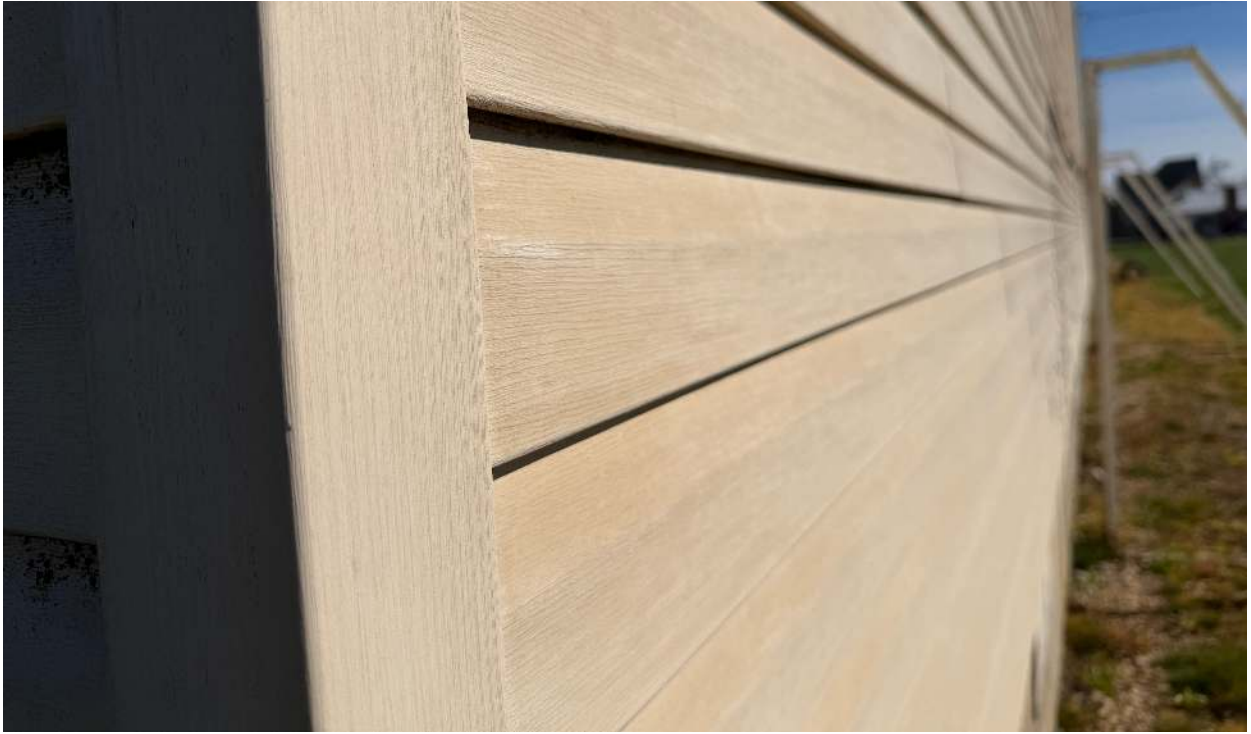
10CN530\_17\_Wall\_Material\_1062\_S.jpg

Close view documenting the horizontal wall cladding and its condition.

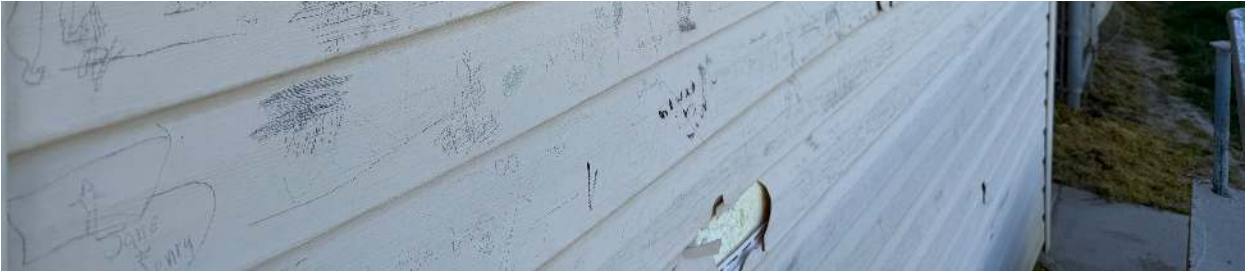
10CN530\_11\_Siding\_Condition\_1051\_NW.jpg

Detail documenting horizontal siding, surface markings, and material condition.

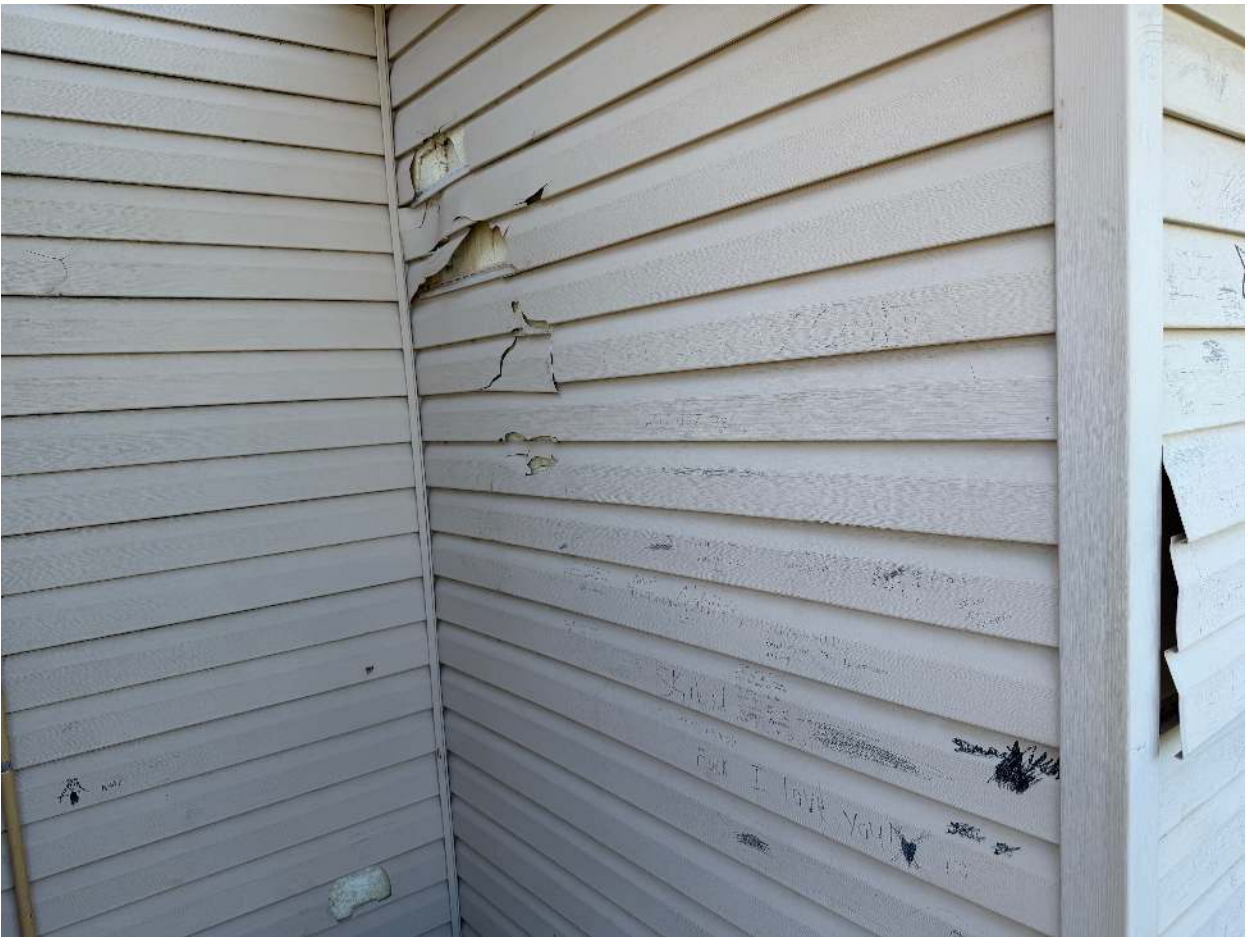
10CN530\_10\_Wall\_Junction\_1050\_NW.jpg

Detail showing the junction between building sections and localized siding damage.
